# **Aquatic Surveys and Assessment within the Butte BLM District**

**Prepared for the Bureau of Land Management, Butte FO  
ESA010009 Task Order #28**

**David M. Stagliano  
Aquatic Ecologist  
May 2006**

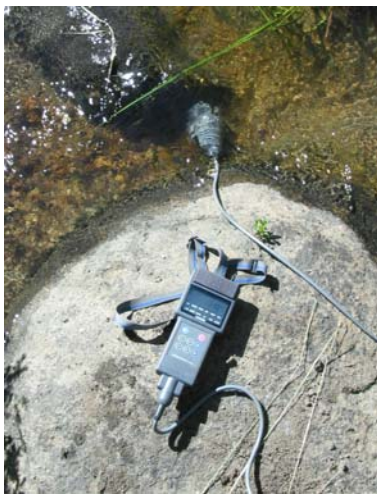
**Figure 1. Water Quality Measurements @ State Creek**

Specific conductivity, pH, water temperature and dissolved oxygen concentration were measured on-site prior to biological sampling with a Yellow Springs Instruments, Inc. model 85 water quality meter calibrated the night before sampling (Figure 1).

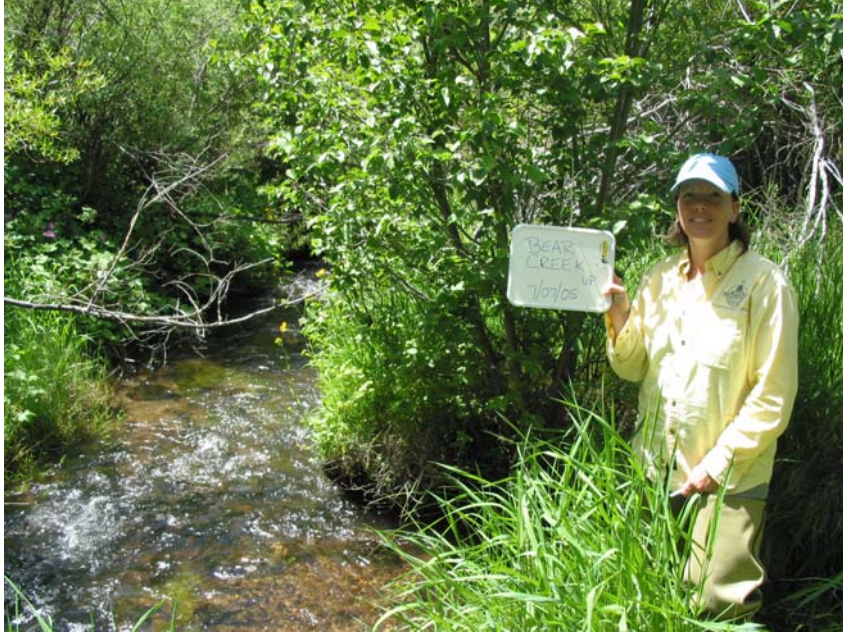
**Bear Creek**-dense (impenetrable in places) willow/alder riparian area, good in-stream substrate with some LWD, minimal livestock use, an old cattle-crossing was slightly widened (where photo is taken). Some old logging in the adjacent (within 30m) left bank riparian area.

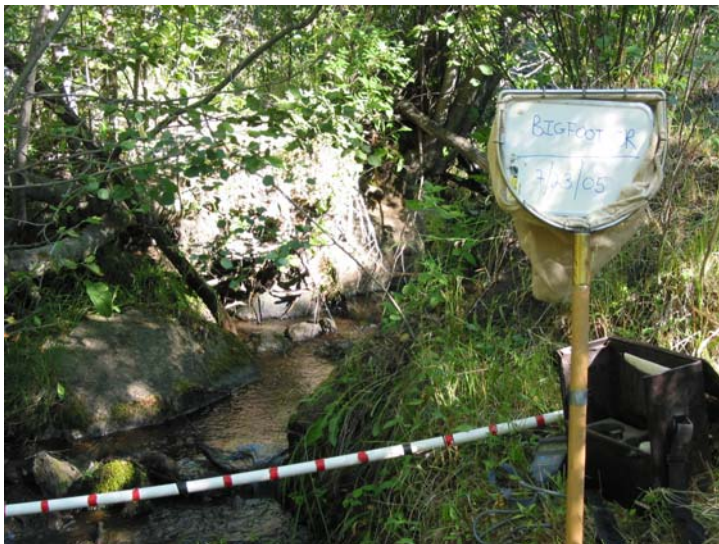
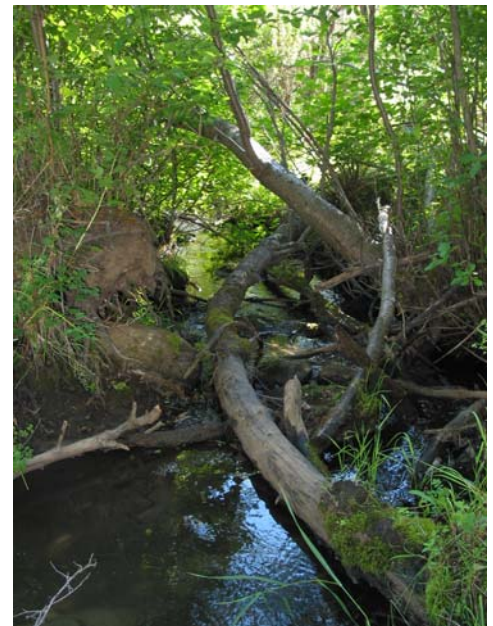
**Bigfoot Creek**- dense alder/willow/poplar riparian area, lots of LWD in the stream channel (right photo), decent boulder/gravel substrate away from the cow crossing areas. Extensive livestock use, pocking, trails and browsing in the riparian area. Silted areas at the cow-crossings and LWD areas.

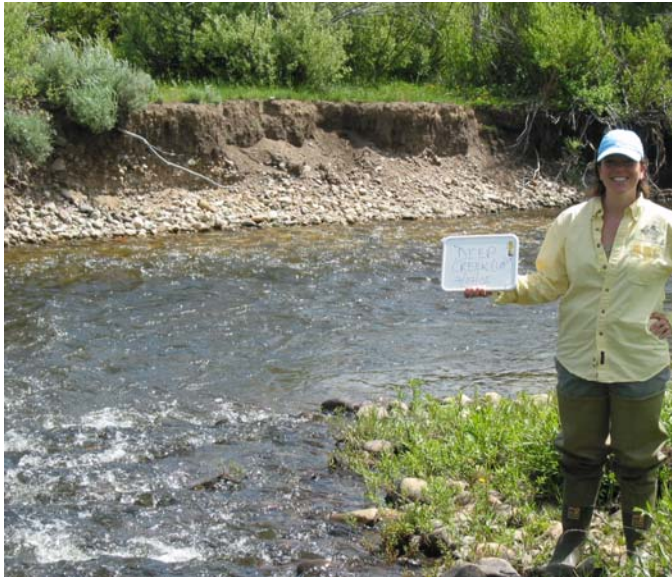
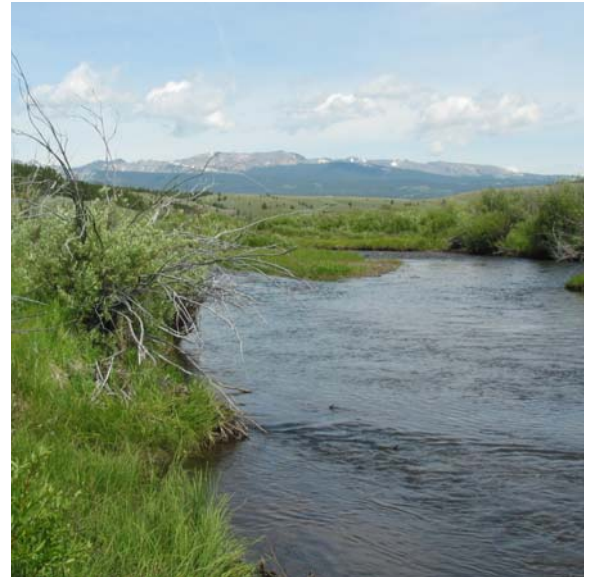
**Deep Creek-**the largest Big Hole tributary sampled, 4<sup>th</sup> order. C3 (riffle/run/pool) geomorphology and cobble/gravel dominated substrate. An increase in fine sediments in the depositional pool areas, largely due to bank stability/cow trampling issues upstream. Left bank riparian habitat is in decent shape, right bank has significant areas of erosional damage (left photo). High quality trout habitat within this reach, plenty of fish holding pools >50 cm.

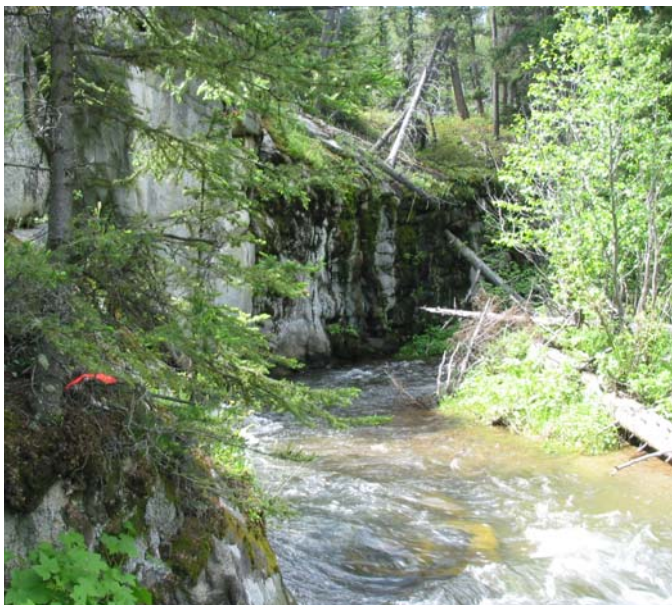
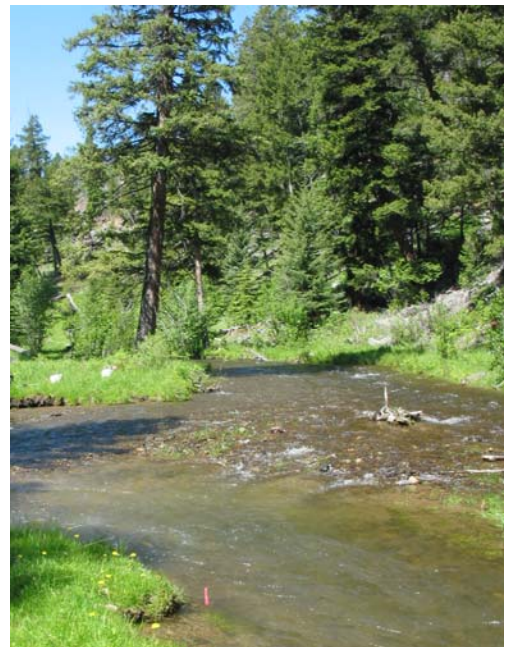
**Fish Creek-** B3-C3 riffle/run/pool geomorphology with boulder/cobble dominated substrate. Rock chasm at the top of reach (left photo). Left bank riparian habitat is in better shape. High quality trout habitat within this reach, numerous fish holding pools >50 cm. Some old logging in the adjacent (within 30m) right bank riparian area.

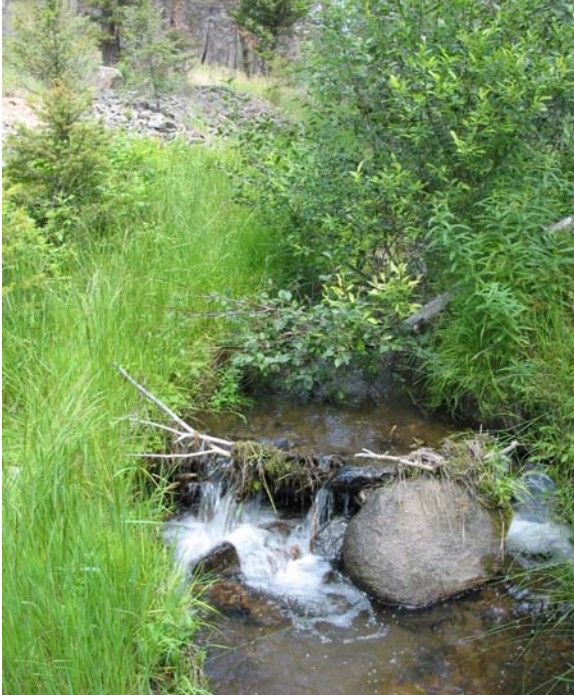
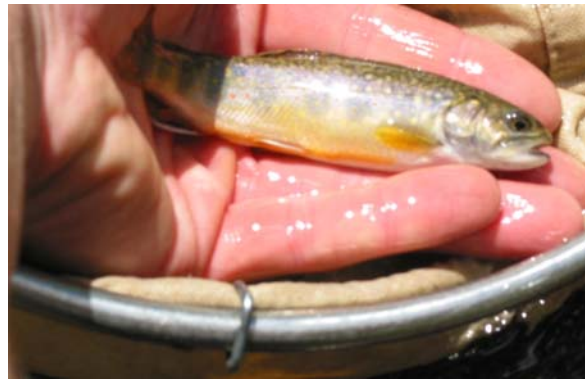
**High Ore Creek**-riffle/run geomorphology and highly embedded, “armored” cobble (really had to rake it out to get a sample) and some loose gravel substrate. Left bank riparian habitat is

recovering from mine tailings while the right bank is in better shape (left photo). Some old logging in the adjacent (within 30m) left bank riparian area as well. Caught an introduced brook trout in the dipnet while taking the macroinvertebrate sample (Right photo).

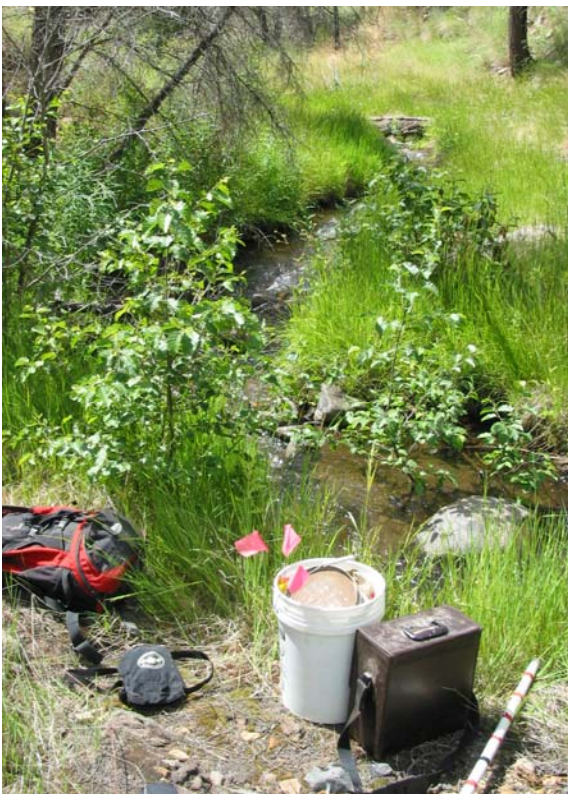
**High Ore Creek**-bottom of reach looking downstream.

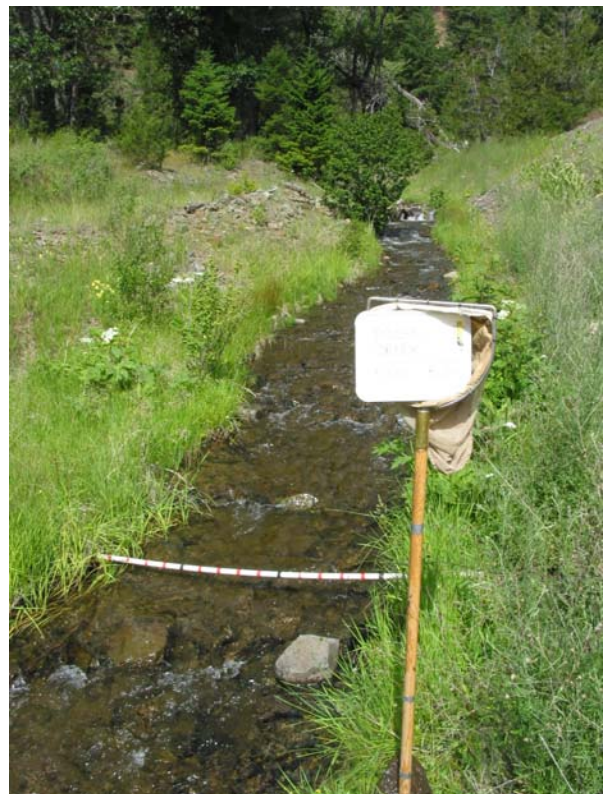
**Indian Creek**-bottom of reach looking upstream.

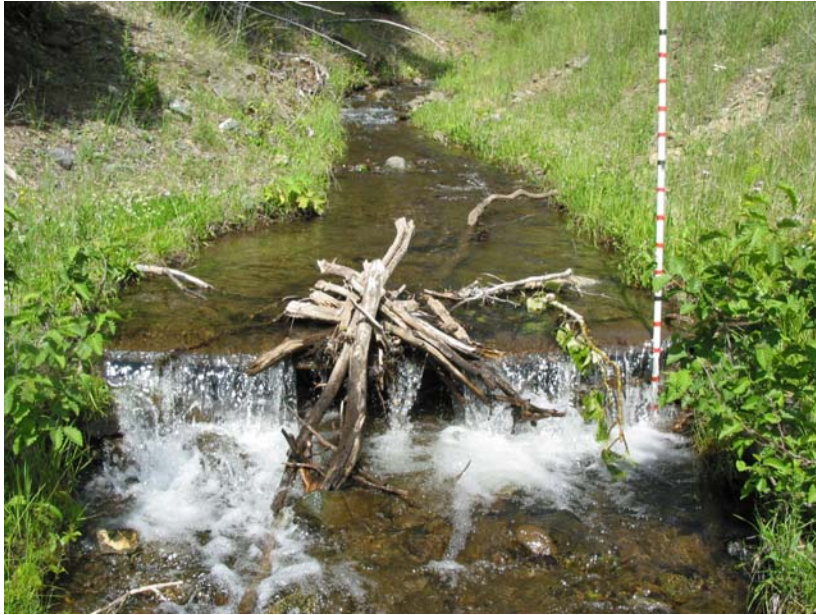
**Indian Creek**-minimal riparian vegetative area except in the upstream portion of reach, some LWD in the stream channel (left photo). Decent cobble/gravel substrate not embedded and macroinvertebrate sample showed no impairment, but this site is still recovering from old mining and substrate removal from the channel. Old tailings piles and road embankment on the right bank looking upstream.

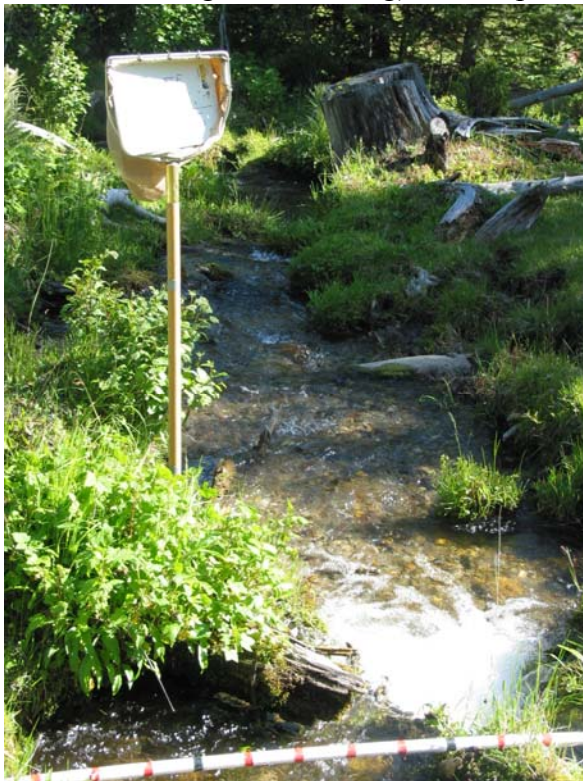
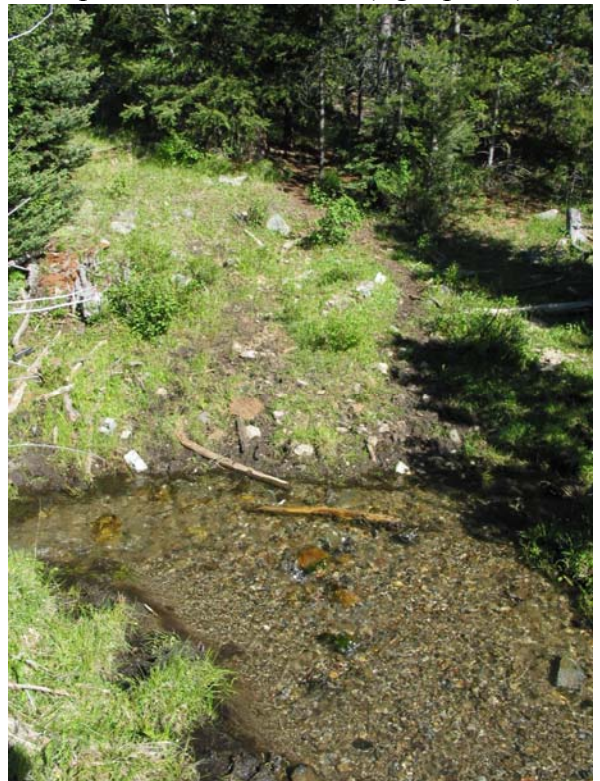
**Jimmie New Creek** –Decent cobble/gravel substrate away from the cow crossing areas. Grassy/shrub riparian area with evidence of old logging (left photo). Moderate livestock use (pocking, stream widening and browsing) in the riparian area of the upstream reach section (right photo).

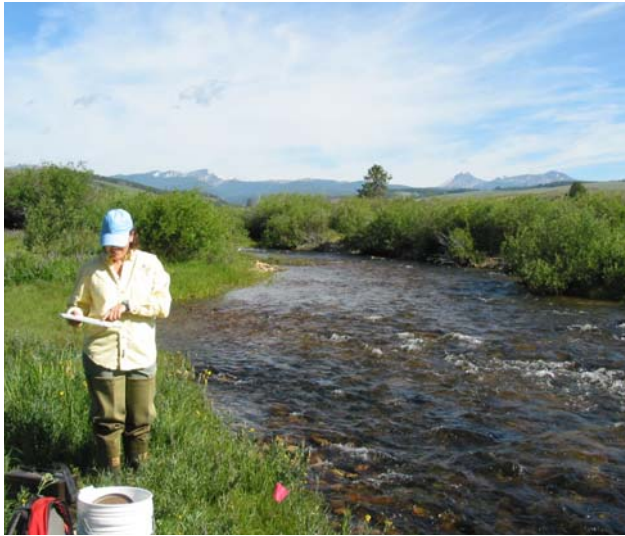
**LaMarche Creek-** C3 riffle/run/pool geomorphology and cobble dominated substrate (left photo). Riparian habitat is dominated by willow and alders (right photo). Some extensive cattle trails and browsing through the riparian area, but little direct impact on the streamside banks. High-quality macroinvertebrate & trout habitat within this reach, plenty of fish holding runs >30 cm deep. A revisit in August revealed no western pearlshell mussels in the reach.

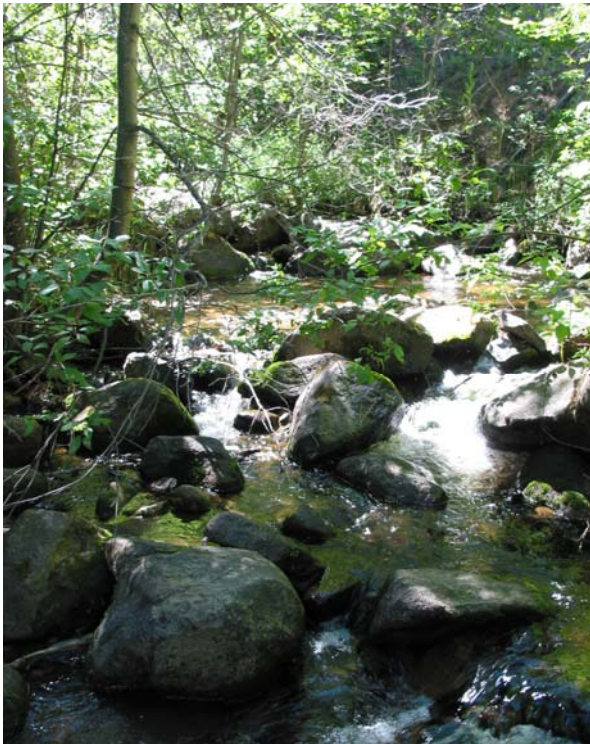
**Lump Gulch-B2** Rosgen step-pool geomorphology and high % of canopy cover (left photo). High quality trout habitat within reach, numerous fish holding pools >30 cm (right photo), and saw trout darting for cover as I sampled. Intact riparian zone with one eroding portion of the bank on the road side (right bank).

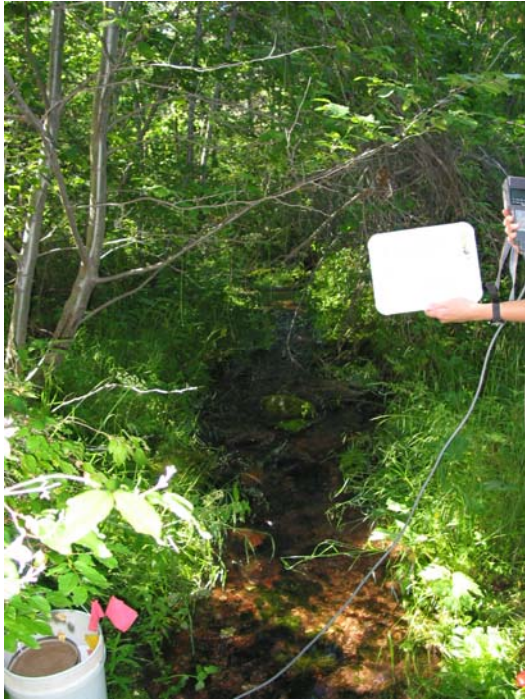
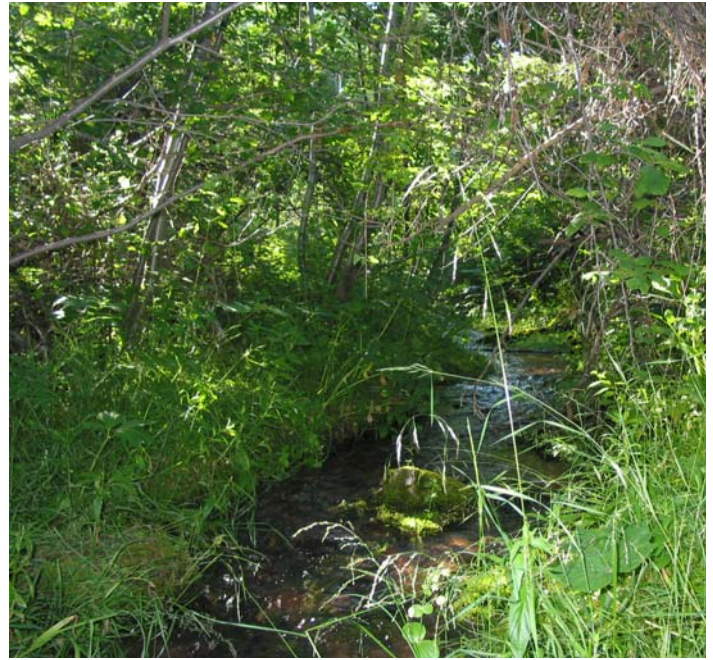
**Medicine Rock Creek**-dense (impenetrable in places) hawthorn/alder riparian area, good in-stream substrate within the narrow single thread channel with some LWD widening some areas. Trout (likely brook trout) seen in the pool formed from a LWD debris dam. Minimal livestock use in the right riparian (old cowpies). Old mining areas upstream and side slope areas to the north of the site across the road.

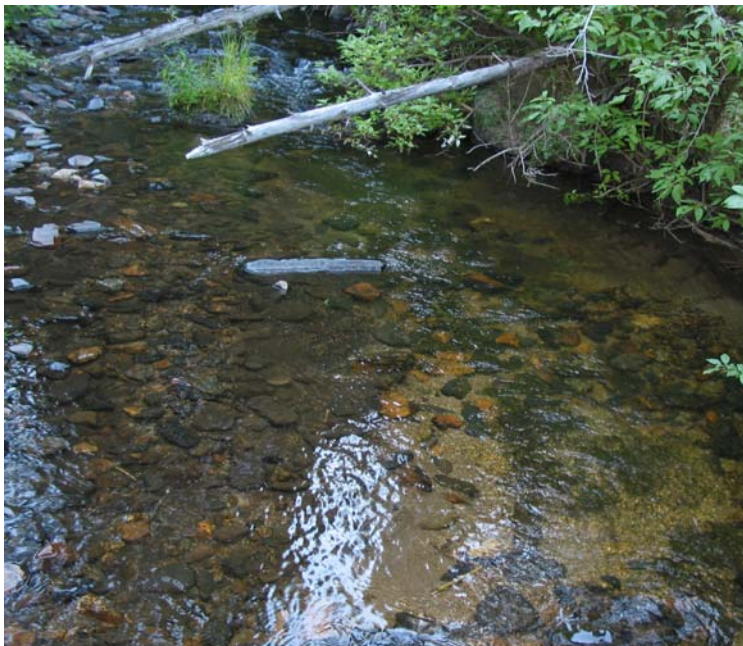
**Moose Creek**-downstream from Humbug Spires trailhead. Intact *Cornus* /alder riparian area, good cobble/gravel substrate (left photo), minimal livestock use. Reference condition C3 low gradient reach, with some bouldered, trout-holding pools (right photo) and sculpin (*Cottus bairdi*) darting around.

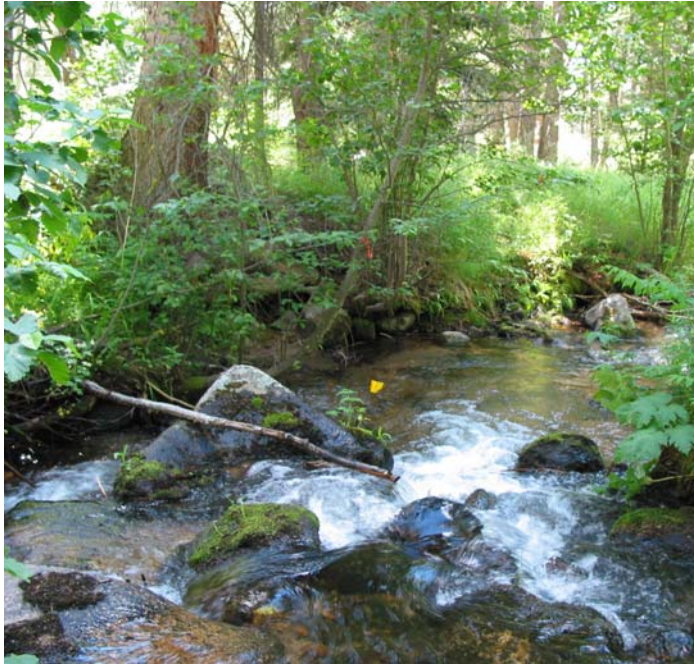
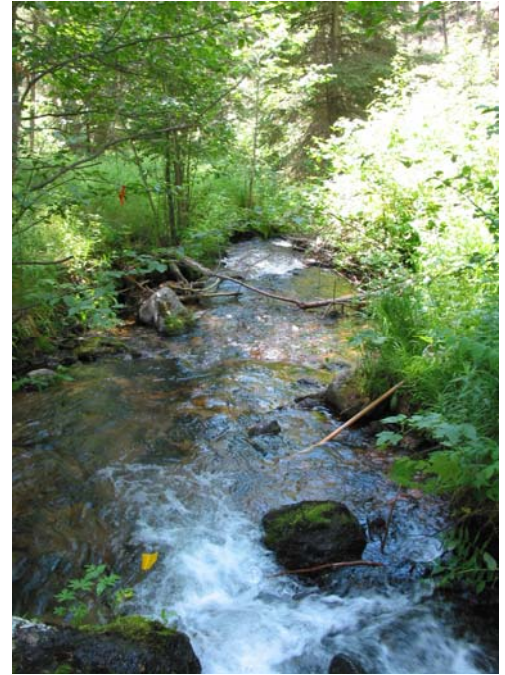
**Muskrat Creek**-downstream end of reach is just up from the trailhead parking area (cover photo). Intact *Cornus* /alder riparian area, great boulder/cobble/gravel substrate, B2-B3 rosgen step-pool geomorphology, minimal/none livestock use. Reference condition moderate-high gradient reach, with trout-holding pools and mottled sculpin (*Cottus bairdii*) darting around.

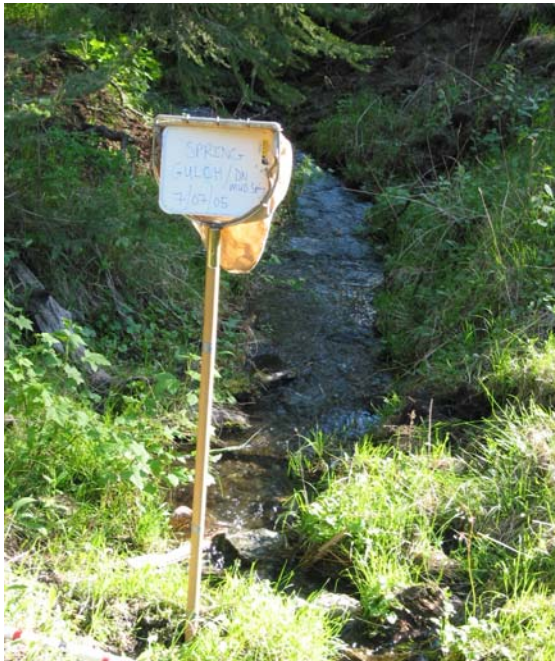
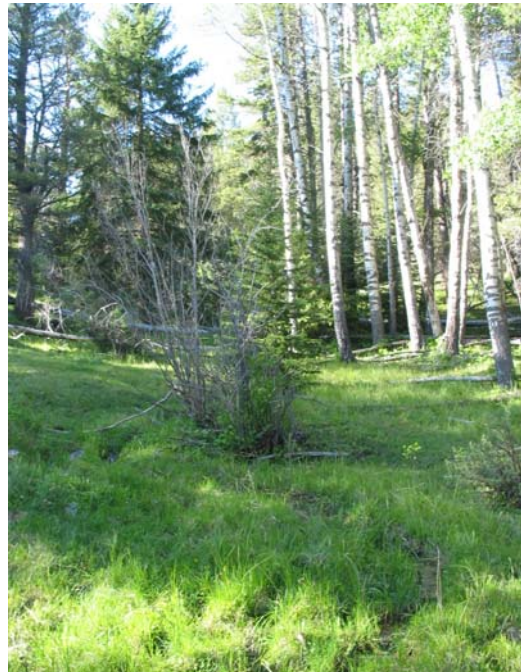
**Spring Gulch** –Decent cobble/gravel substrate away from the cow crossing areas. Grassy/ shrub riparian area (left photo). Extensive livestock use (pocking, widening and browsing) in the riparian area of the upstream reach section (right photo).

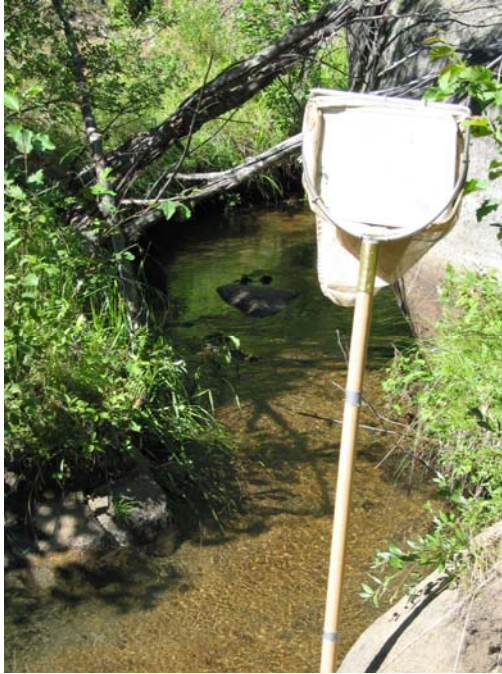
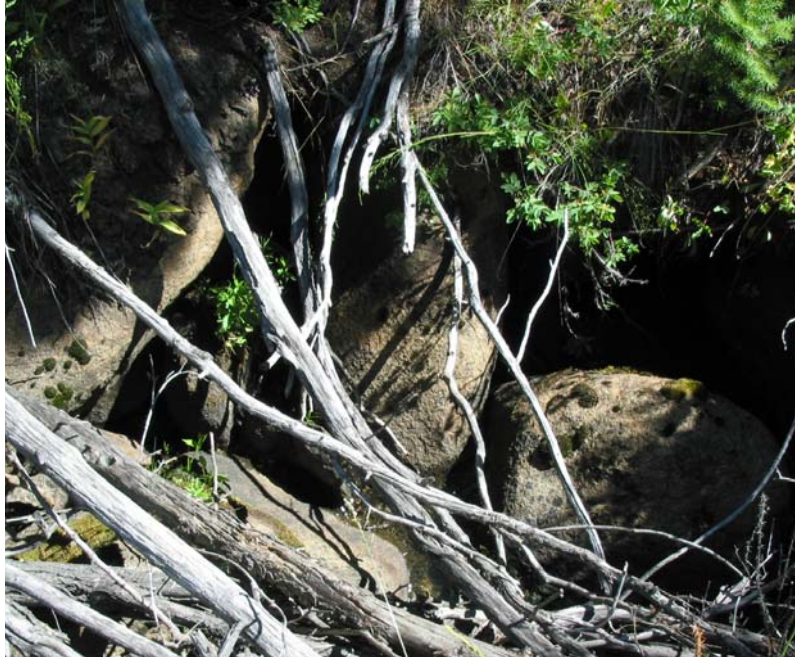
**State Creek** –B2 boulder/gravel substrate away from the cow crossing areas which have become slightly widened. Alder/ shrub riparian area (left photo). Extensive blockage of parts of the reach by boulders & LWD, trout using this cover, saw many darting underneath (right photo).

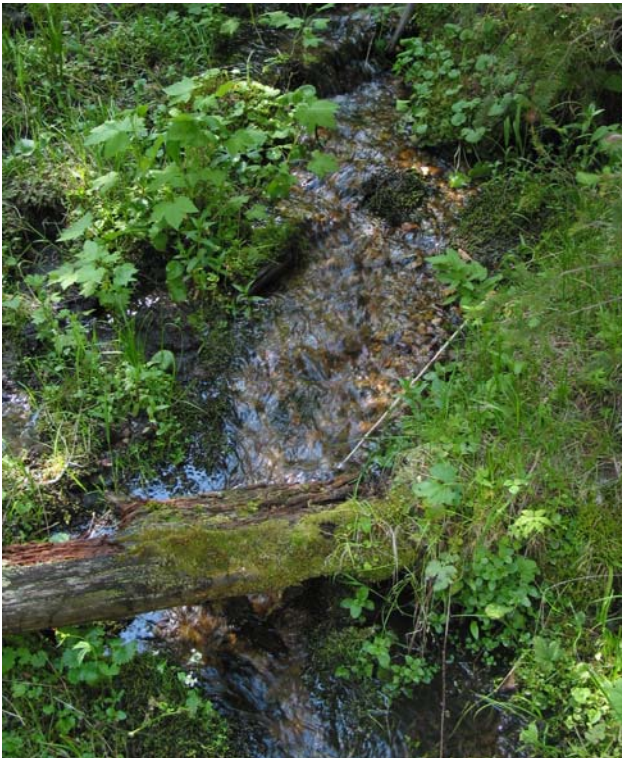
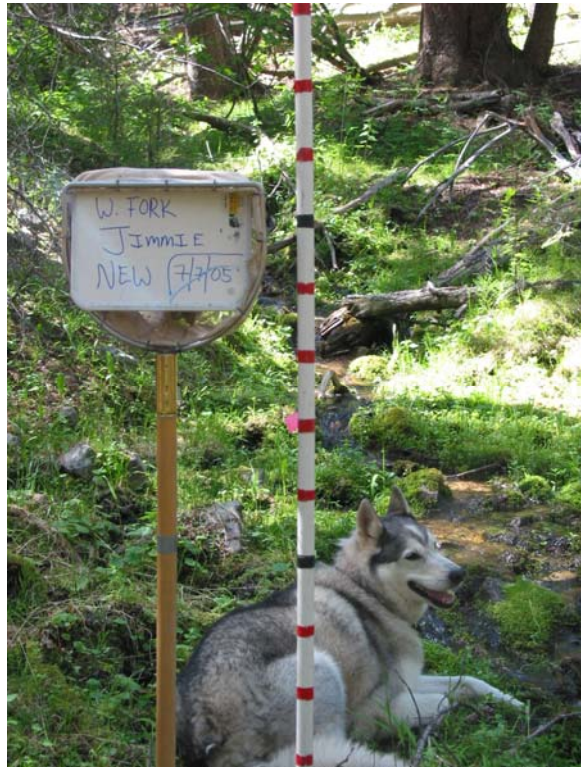
**West Fork Jimmie New Creek**-A narrow, single-thread channel with good cobble/gravel substrate and some LWD, flowing within a nicely wooded gulch. Minimal livestock use.

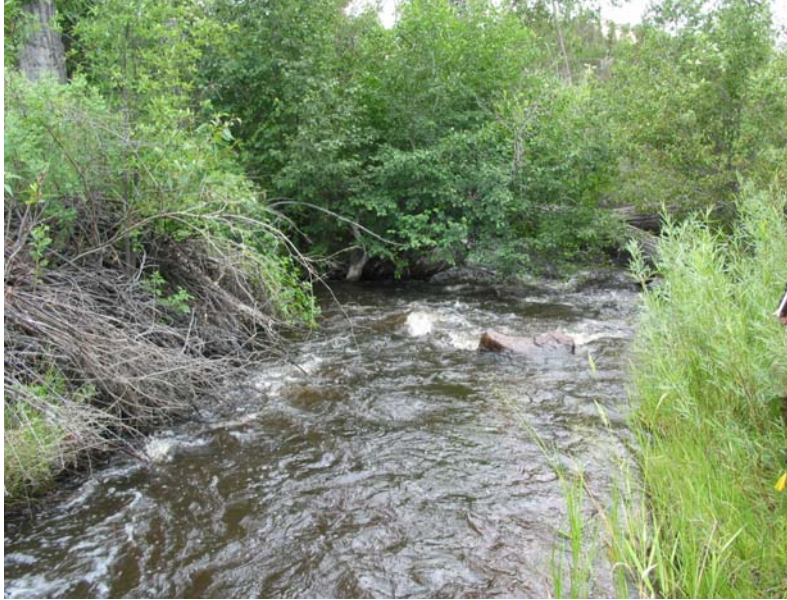
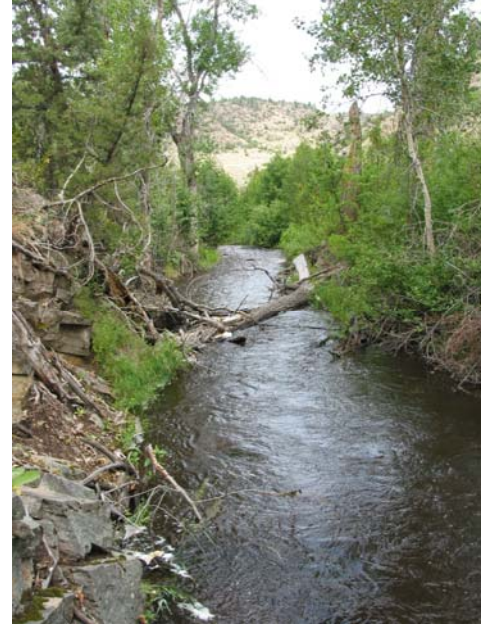
**Whitetail Creek-** C3 riffle/run/pool geomorphology and cobble dominated substrate. Left bank riparian habitat has higher integrity. Quality trout habitat exists within this reach, plenty of fish holding runs, LWD & pools >50 cm.
